PROCEEDINGS OF THE 1980 TRI-SERVICE  
CONFERENCE ON CORROSION

VOLUME II

Fred H. Meyer Jr., Editor  
Air Force Wright Aeronautical Laboratories  
Materials Laboratory

November 1980

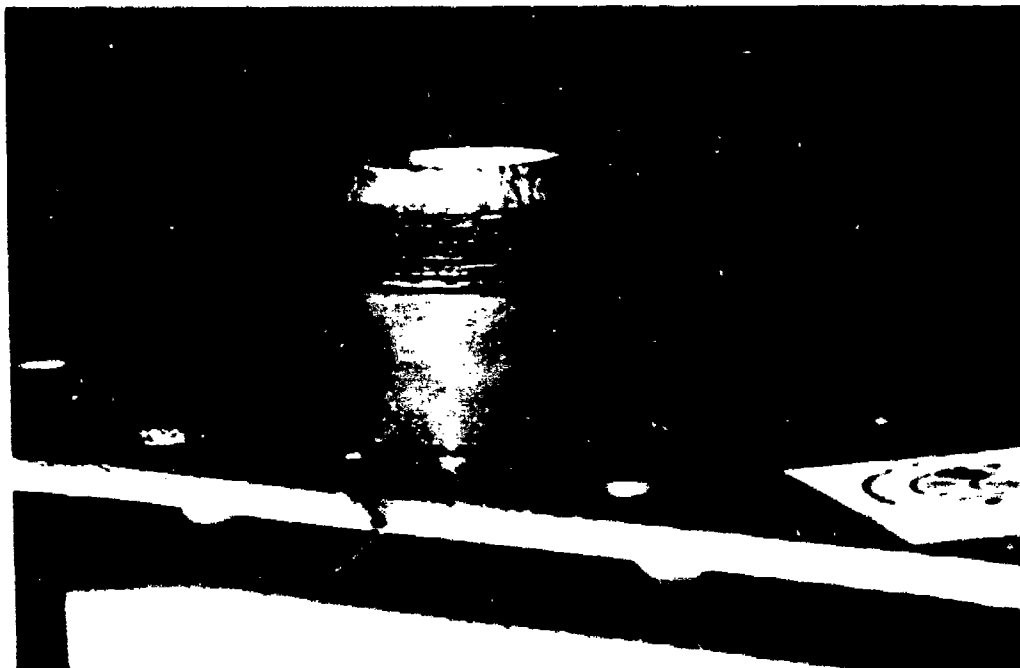
Figure 7. Corrosion on Lower TACAN/IFF Antenna Coaxial Connector

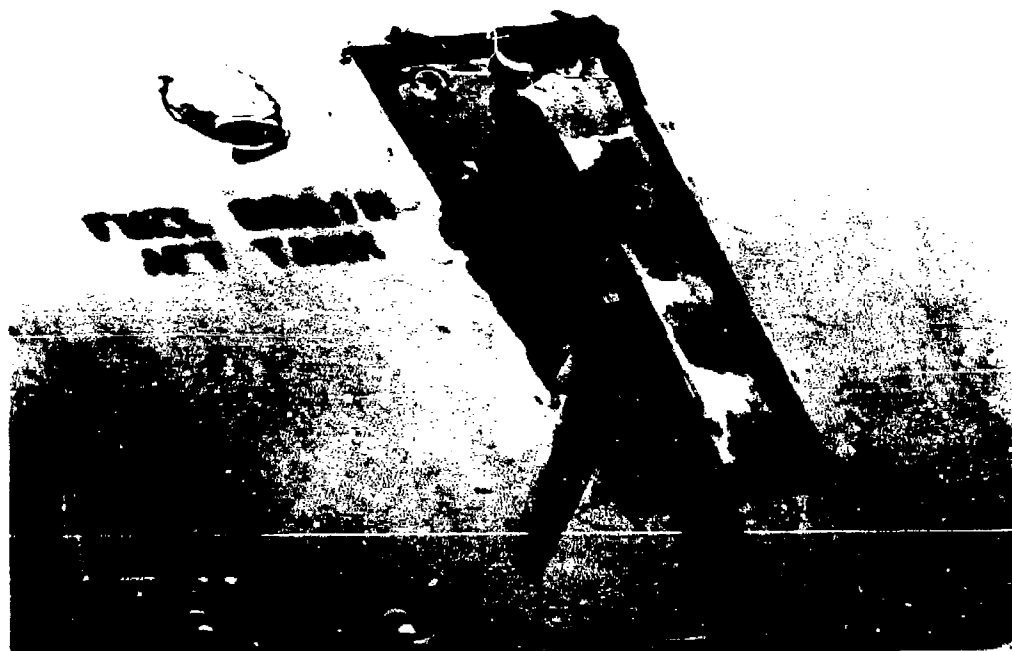
Figure 8. Sealed A-7 Lower TACAN/IFF Antenna

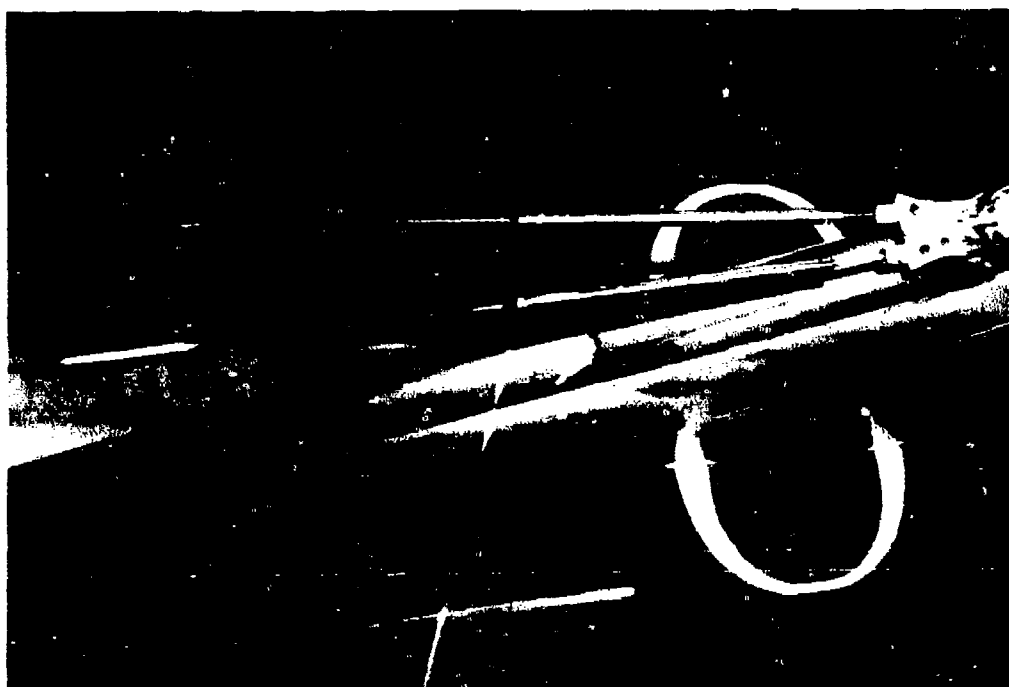
Figure 10. P-3 HF Long Wire Tensioner
